King Highway Landfill OU – 2012 3rd
Quarter Landfill Inspection Report

**KING HIGHWAY LANDFILL
POST-REMEDIATION INSPECTION FORM**

ALLIED PAPER, INC./PORTAGE CREEK/
KALAMAZOO RIVER SUPERFUND SITE
**STRESSED VEGETATION AND GEOMEMBRANE
LINER REPAIR ACTIVITIES**

**CURRENT STATUS OF COMPLETED
STRESSED VEGETATION AND
GEOMEMBRANE LINER REPAIR**

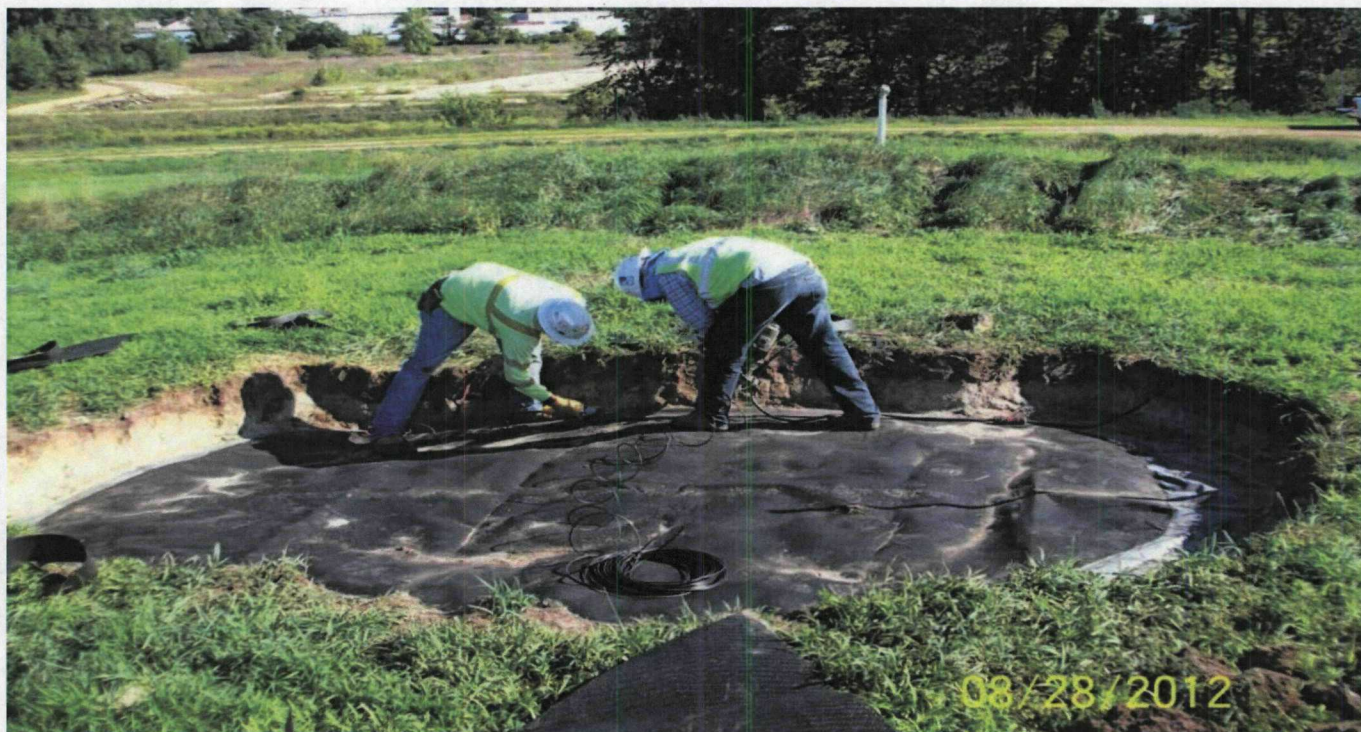
Photo No. 1: Looking north at the patch being extrusion welded to the existing liner to repair the breaches in the liner.

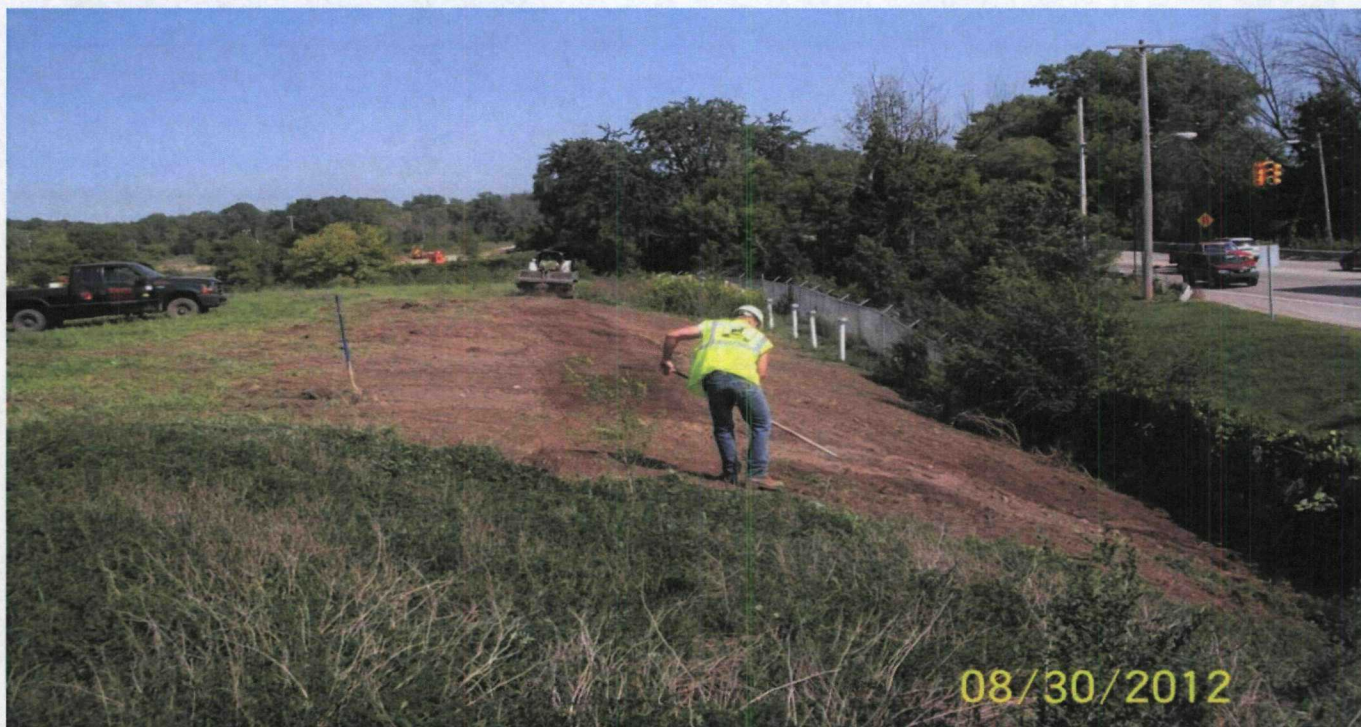
Photo No. 2: Looking east at Terra Contracting, LLC (Terra) preparing the area of stressed vegetation for re-seeding.

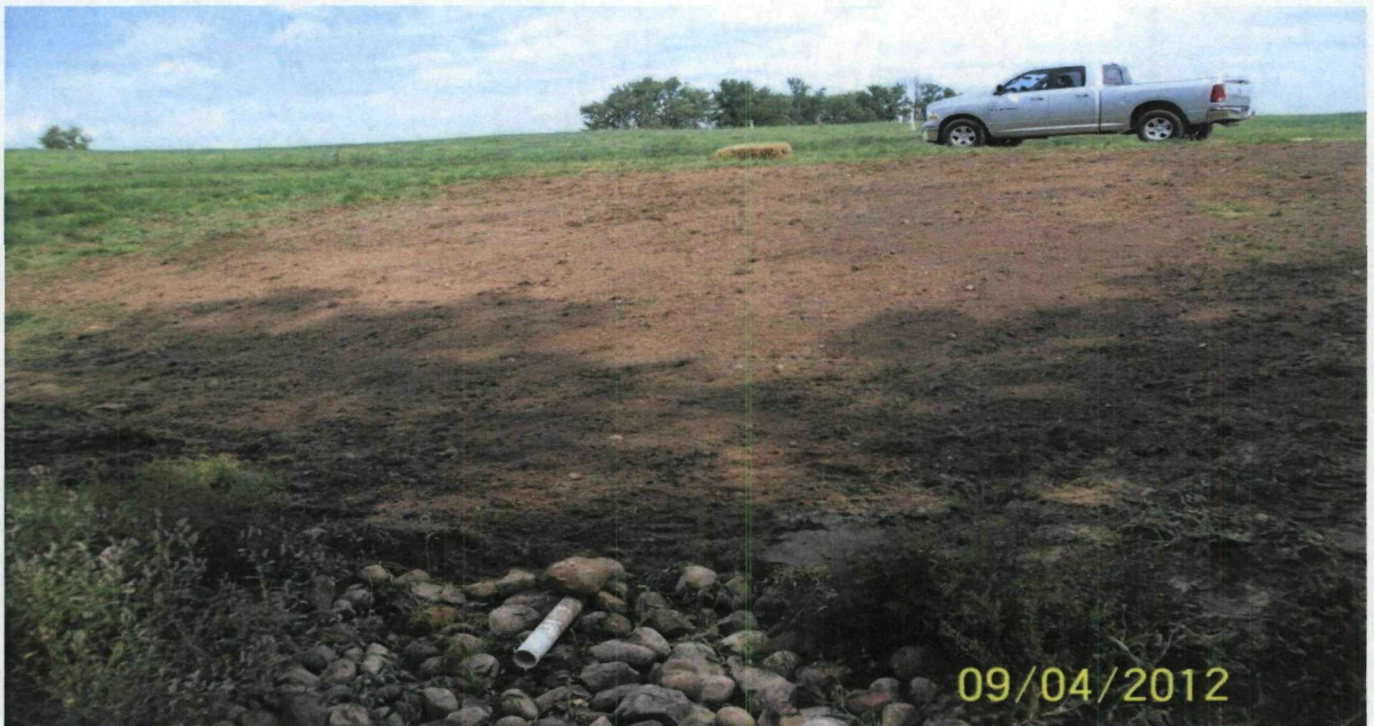
Photo No. 4: Looking east at the southern pore water outlet pipe that has been extended into the riprap spillway.

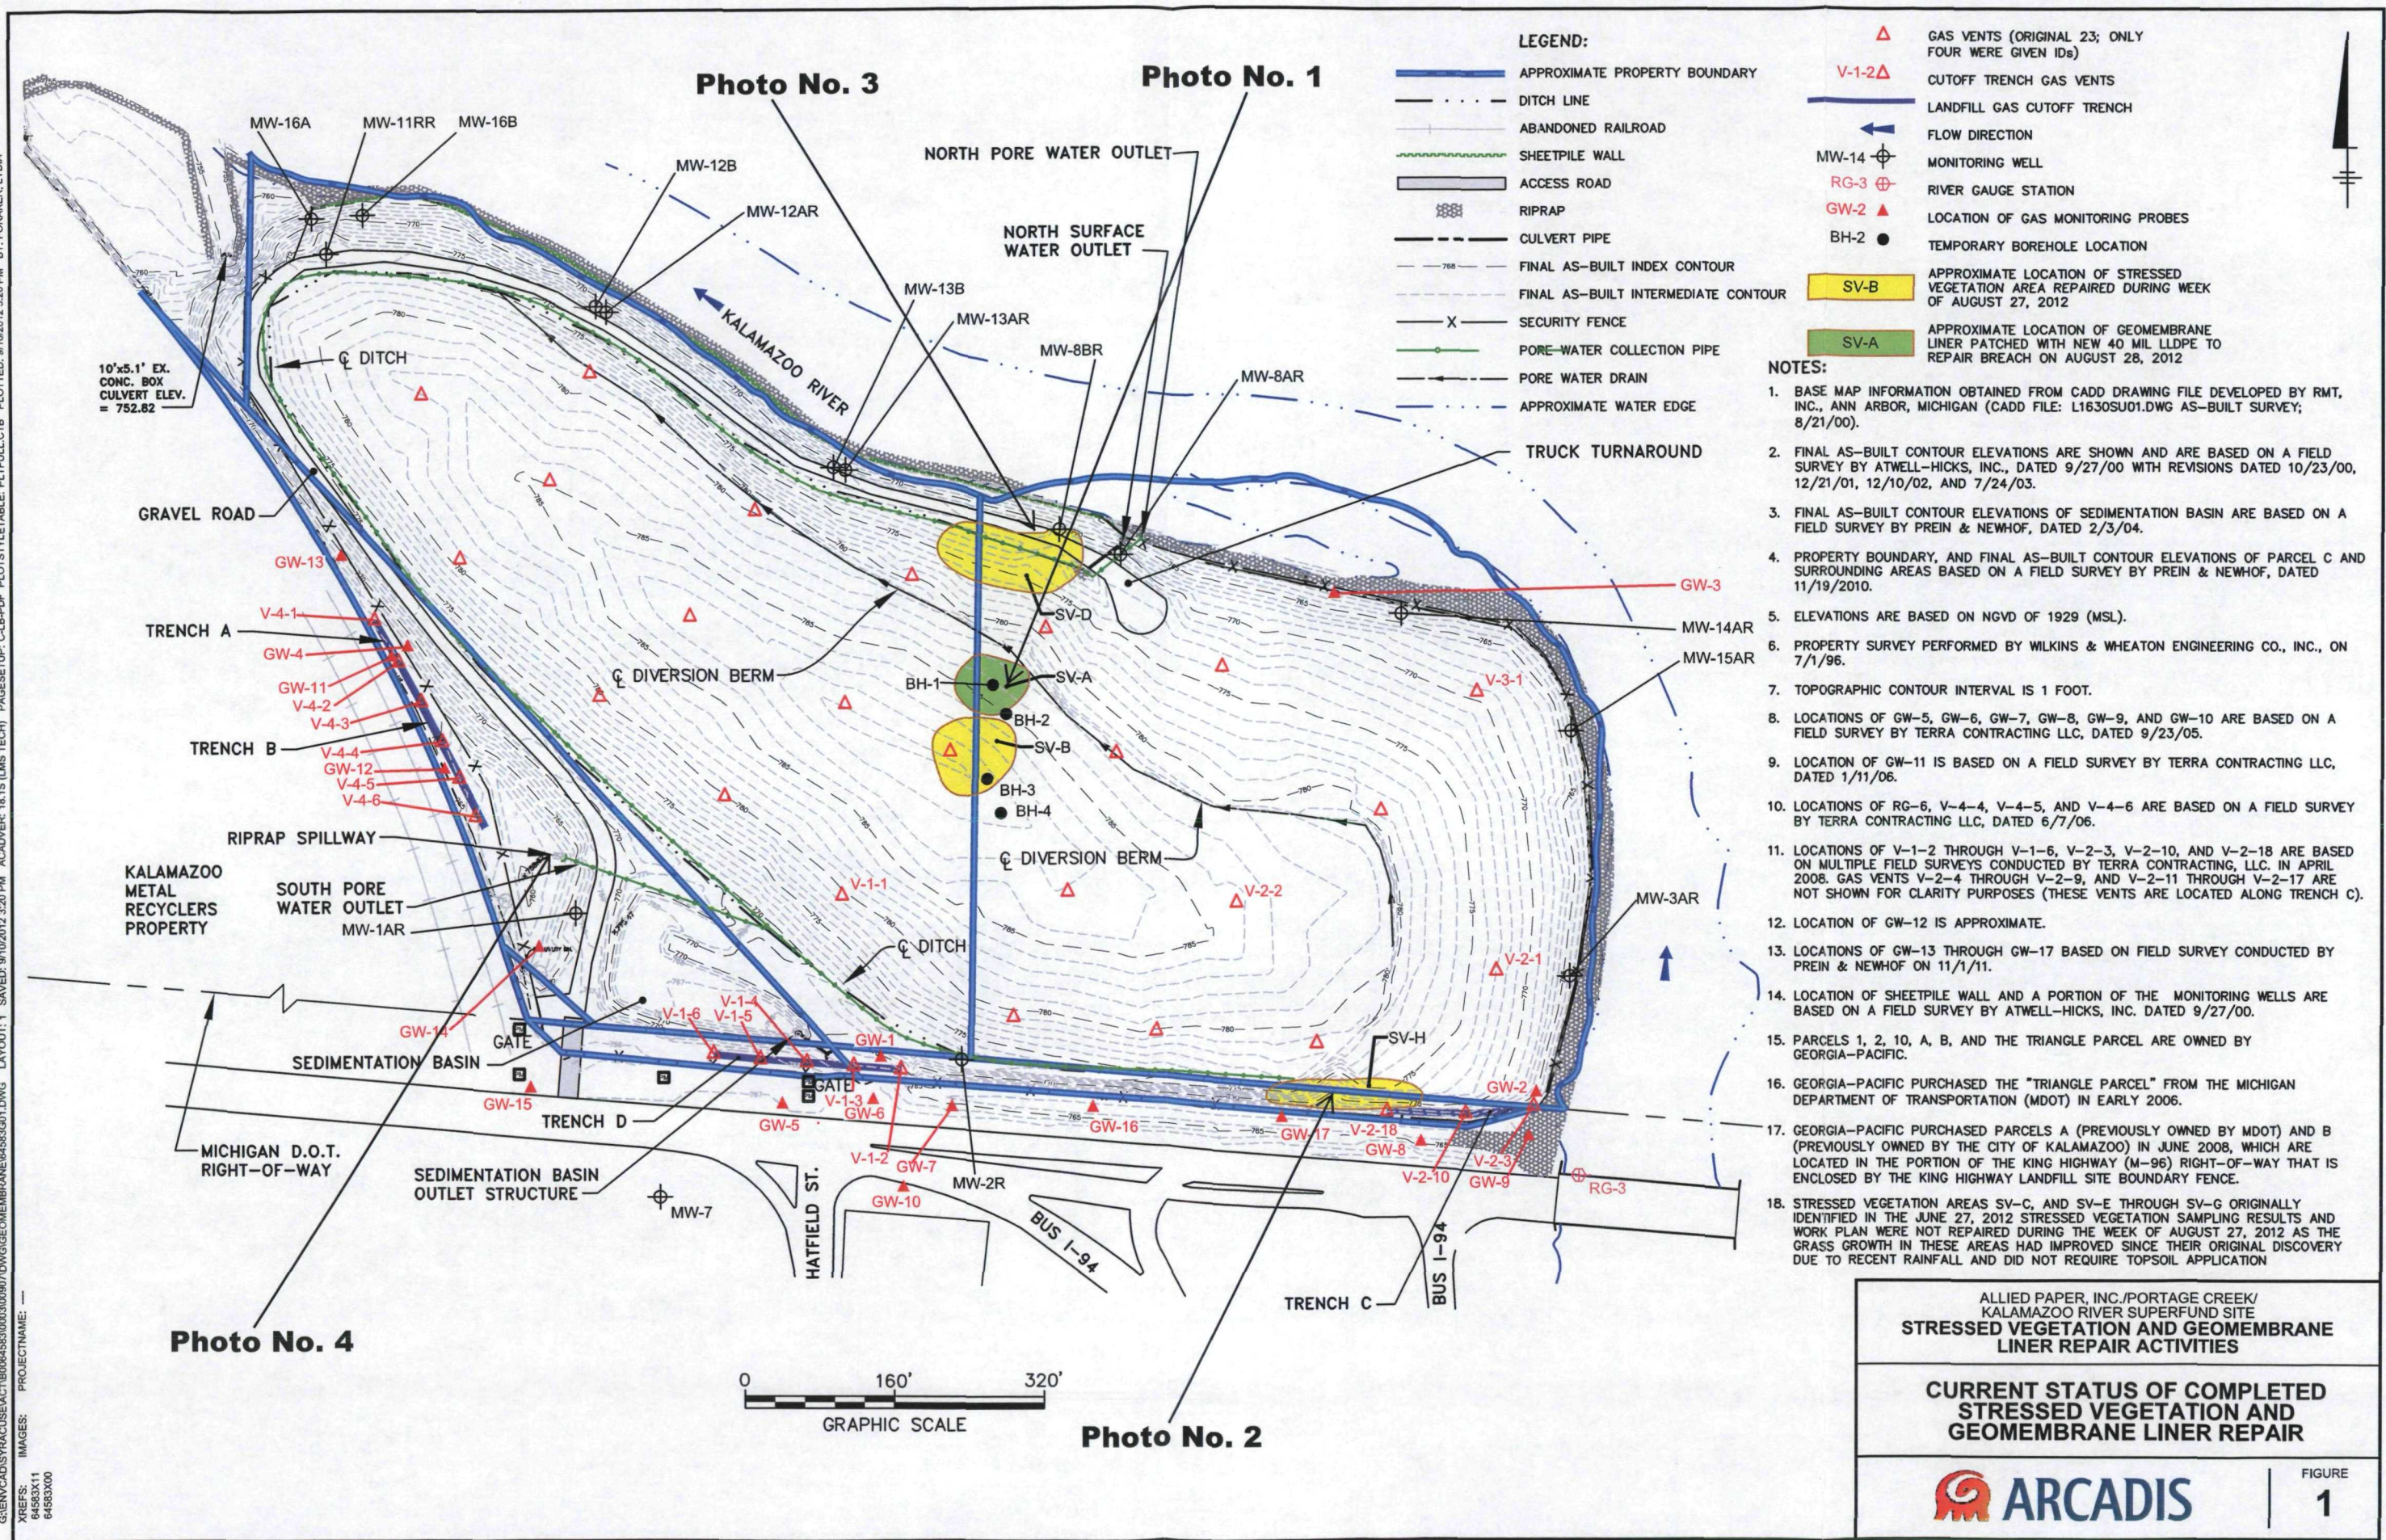
FIGURE
1

18. STRESSED VEGETATION AREAS SV-C, AND SV-E THROUGH SV-G ORIGINALLY IDENTIFIED IN THE JUNE 27, 2012 STRESSED VEGETATION SAMPLING RESULTS AND WORK PLAN WERE NOT REPAIRED DURING THE WEEK OF AUGUST 27, 2012 AS THE GRASS GROWTH IN THESE AREAS HAD IMPROVED SINCE THEIR ORIGINAL DISCOVERY DUE TO RECENT RAINFALL AND DID NOT REQUIRE TOPSOIL APPLICATION
